UNDERGROUND STORAGE TANK (UST) ASSESSMENT REPORT FOR BUILDING 54 CNC
CHARLESTON SC
10/17/1996
ENVIRONMENTAL DETACHMENT CHARLESTON

**UST ASSESSMENT REPORT
UST BLDG 54
NAVAL BASE CHARLESTON
CHARLESTON SC**

South Carolina Department of Health and Environmental Control (S.C.D.H.E.C.)
Underground Storage Tank (UST) Assessment Report

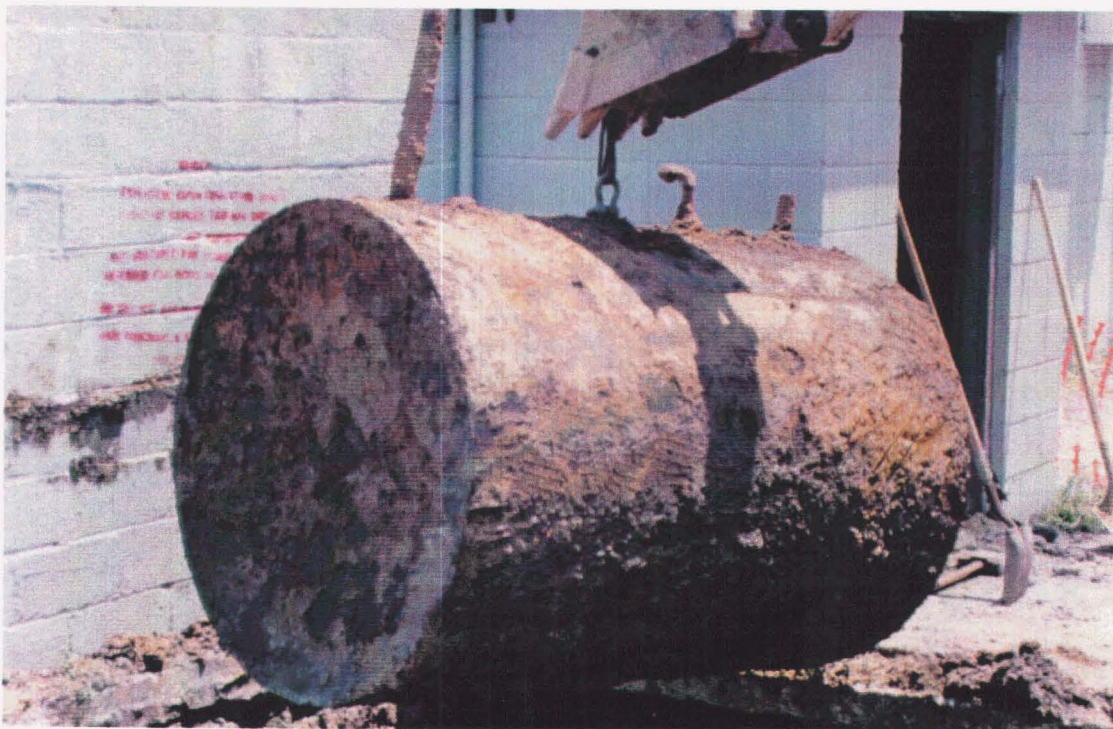
Photo 2: Removal in progress.

The UST was removed from the ground, drained, and cleaned. It was then cut up for recycling as scrap metal. See Attachment III.

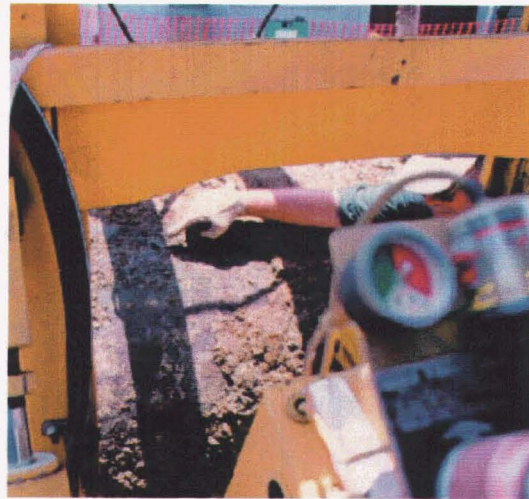
UST BLDG 54 was corroded, pitted, and had several holes. The holes ranged from 1/4 to 1/8 inch in diameter. They were located from the middle of the tank up. See Attachment I.

Photo 4: A second 1/4 inch hole is being indicated.

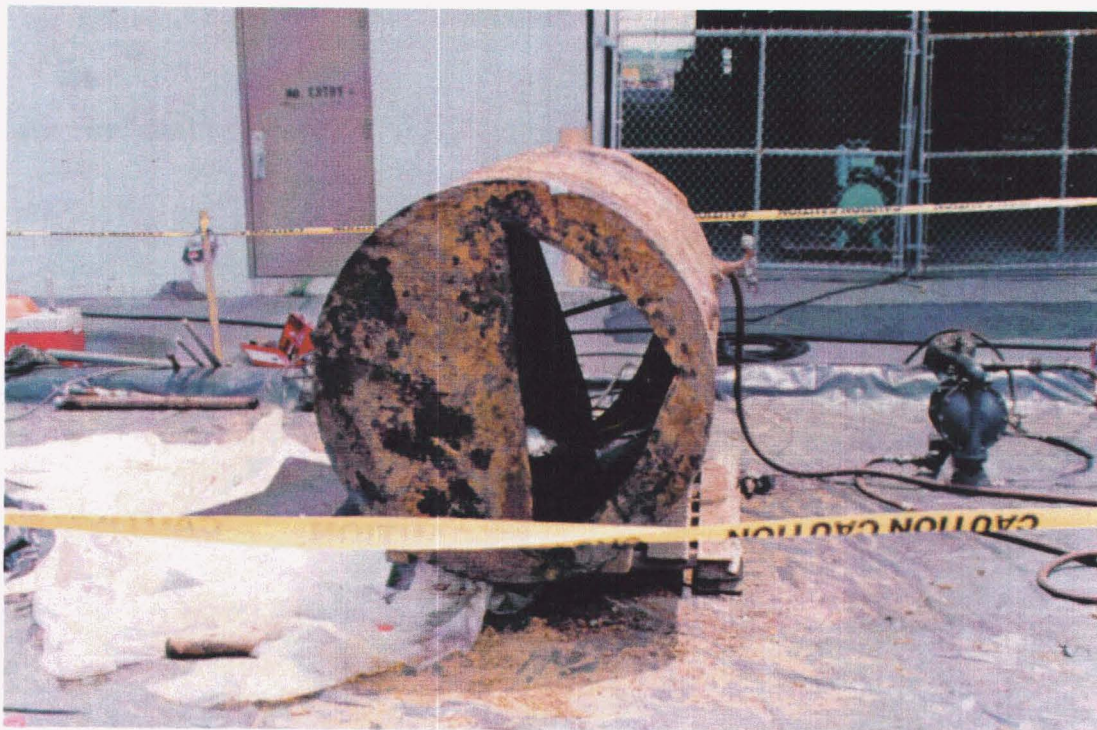
Photo 5: UST BLDG 54 ends cut open for steam cleaning.
